Pump Repair with Belzona

ID: 7604

Industry: *Fluid Flow*
Application: *CEP-Centrifugal Pumps*
Substrate: *Stainless Steel*
Products: *Belzona® 1311 (Ceramic R-Metal)*
Belzona® 1391 (HT)

Customer Location: *Cellulose production plant, Slovakia*
Application Date: *2010*

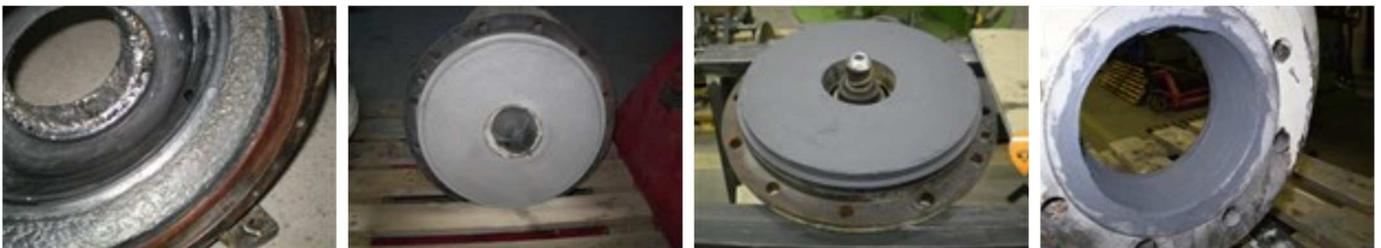
Corrosion and erosion from chemicals (caustification plus CaCO_3 a CaO).

1. Damaged pump
2. After blasting
3. Belzona® 1311 application
4. Belzona® 1391 application

Pump erosion and corrosion every 6 months.

Application was carried out in accordance with Instructions for use.
