PVC Pipe Repair

ID: 8403

Industry: Fluid Flow
Application: VPF-Valves, Pipes and Fittings
Substrate: Polyvinyl chloride (PVC)
Products: Belzona® 1221 (ES-Metal)

Customer Location: Malacky, Slovakia
Application Date: 2020

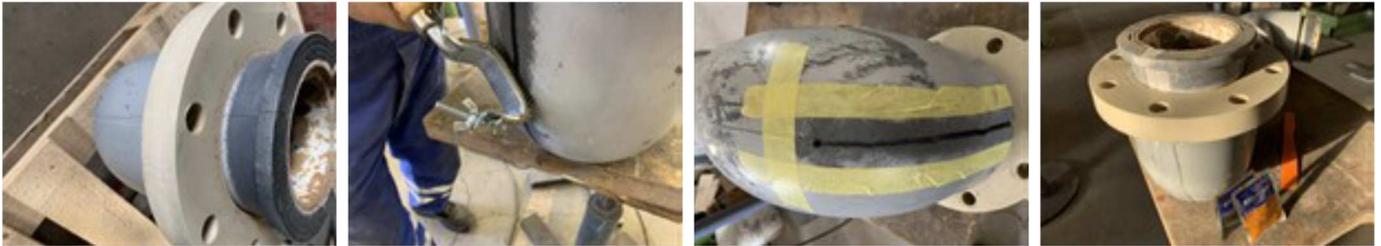
Photograph Descriptions

1. Customer needed to repair the crack
2. We roughened surround place using the Belzona roughing brush
3. Ready for Belzona® 1221 application
4. Repaired pipe bend

Customer destroyed a PVC pipe bend (diameter 160 mm, wall thickness 10 mm, with hydrostatic pressure, temperature up to 20°C) during some cooling tower dismounting and maintenance.

Application was carried out in accordance with Instructions for use. Firstly we made the test with Belzona® 1221 application on the small area of this bend. Adhesion was perfect. Then we started to repair the entire crack. We terminated the crack by drilling 6 mm hole at the end to prevent further propagation, "veed" out crack with a handheld machine, then roughened it using the Belzona roughing brush. After chemical cleaning was Belzona® 1221 applied.
