# Belzona Keeps Vehicles Moving

Customer Location: *Vehicle testing station Bratislava, Slovakia*

Application: *FPA-Floor Problem Areas*

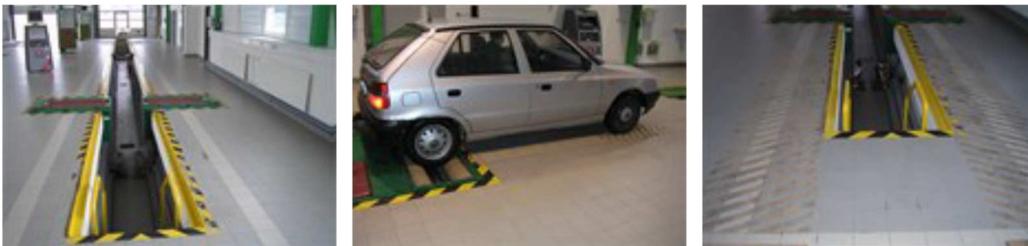
*During the rain or snow, vehicles were slipping when moving off the brake testing rollers.*

1. Vehicle testing station
2. Vehicle during the brake testing
3. 2 years in service

Application was carried out in accordance with Instructions for use. Belzona® 5811 was applied by brush in a diagonal stripe pattern and blinded with Belzona® 9211.
