Belzona Stops Floor Drain Leaks

ID: 2458

Customer Location: Machinery manufacturer, Slovakia
Application Date: 2008

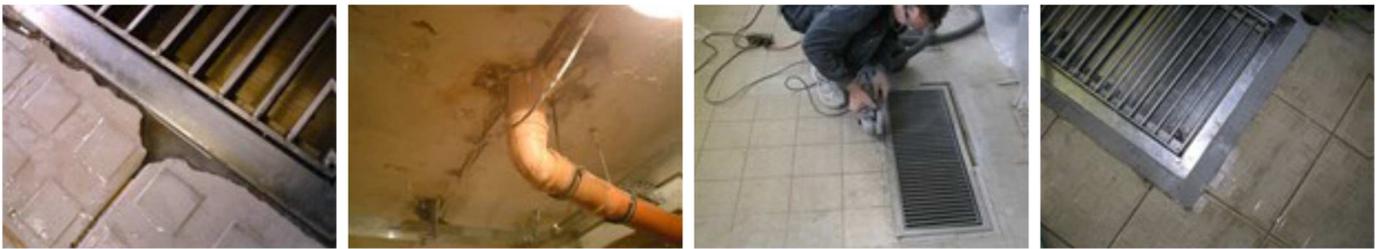
Photograph Descriptions

Leakage from the floor drains was problem from the start. Connection between steel and tiles was faulty. Result was the leakage to the next floor.

1. Situation before repair
2. Situation at the floor below
3. Surface preparation being carried out
4. Belzona® 4111 in place creating a watertight seal

Customer had tried several alternatives to repair the drain but none worked. Repair with Belzona® 4111 ensured necessary water tightness due to excellent adhesion to different substrates and non-shrink properties.
