Belzona Repairs Blower Wheel

Industry: General Industry
Application: SHM-Solids Handling Machinery
Substrate: Steel
Products: Belzona® 1811 (Ceramic Carbide),
Belzona® 1821 (Ceramic Carbide FP)

Customer Location: Cement producer, Slovakia
Application Date: 2016

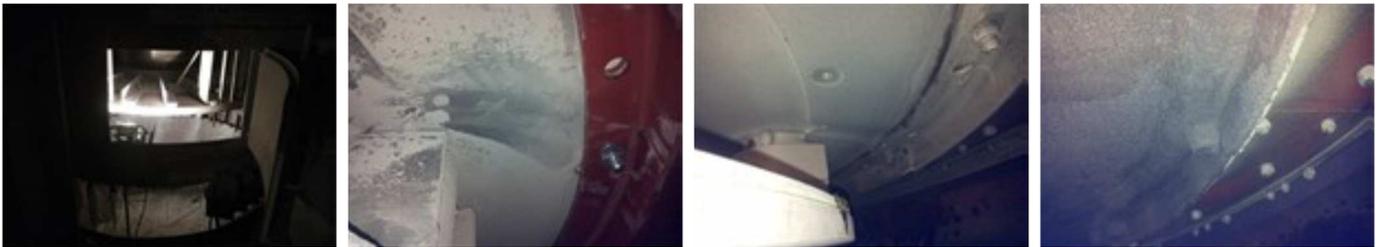
Photograph Descriptions

Where the cement hits some areas of the blower, they experienced severe abrasion and erosion. They required an alternative to welding fresh metal plates to reinstate lost material.

1. Blower
2. Damaged areas
3. After grit blasting
4. Belzona® 1811 application

In some cases, it was not possible to weld new plates as substrate was too thin and in difficult to reach areas. Belzona protection was a faster and more effective solution. It is also easier to maintain in future.
