Belzona Repairs Air Pipe Distributor

ID: 7596

Customer Location: *Cement producer, Slovakia*
Application Date: *2016*

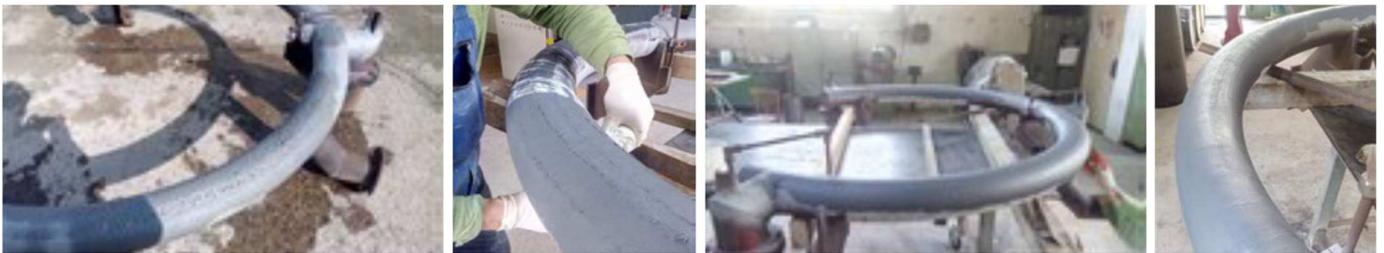
Photograph Descriptions

Whilst the system was offline, condensed gases created corrosion (deep 3 mm) on the DN 125 air pipe distributor.

1. Air distributor after blasting
2. Belzona® 1111 plus reinforcement tape
3. Full extent of the pipe
4. Belzona application complete

Due to the size and complexity of the pipe, there was an extremely long lead time on a replacement, as well as considerable costs. The Belzona repair restored strength to the pipe and prevented future corrosion damage.
