# Belzona® 1593 Special Internal Coating

ID: 8395

Application: HEX-Heat Exchangers

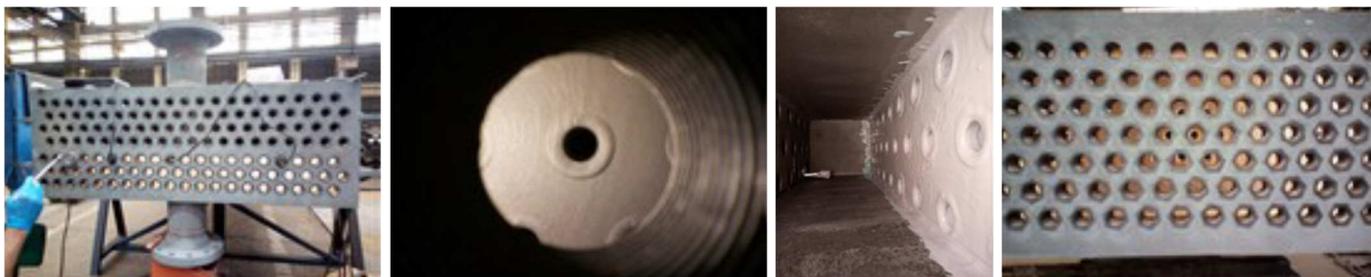
## Photograph Descriptions

Chemical attack (corrosion) was only one problem, another problem was that coating area was not easily available.

1. Customer needed to protect internal tube sheet
2. We needed to use special tools for blasting
3. Tube sheet was coated with product Belzona® 1593
4. Ready to work

We needed to use special tools for blasting through the threaded holes with diameter 18 mm. Also we had to protect that thread. After blasting and cleaning, a tube sheet was coated with product Belzona® 1593 in 2 layers. Application was performed in accordance with modified Instructions for use.
