Belzona Solution for Neutralization Tower

ID: 1066

Industry: *Chemical & Petrochemical*
Application: *TCC-Tanks and Chemical Containment Areas*
Substrate: *Steel*
Products: *Belzona® 4331 (Magma CR3)*

Customer Location: *Chemical plant, Slovakia*
Application Date: *2001, 2003, 2004, 2006*

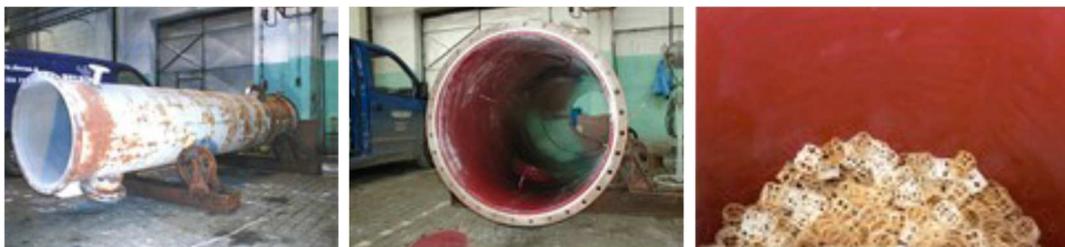
Photograph Descriptions

Corrosion caused by presence of aggressive chemicals including Vinyl Chloride, Sodium Hydroxide, Methyl Chloride and Hydrogen Chloride.

1. Neutralizing tower after blasting operation
2. Belzona® 4331 applied
3. Ready to operate

Reaction tower used in production of Vinyl Chloride.

Application was carried out in accordance with Instructions for use.

Customer carried out trials on various coatings and most were destroyed within weeks. Belzona® 4331 gave best results being intact after 2 years. Client has since coated all 4 towers with Belzona® 4331.
