Concrete Bund Restored

ID: 7588

Industry: *Chemical & Petrochemical*
Application: *TCC-Tanks and Chemical Containment Areas*
Substrate: *Concrete*
Products: *Belzona® 4301 (Magma CR1 Hi-Build),
Belzona® 4311 (Magma CR1)*

Customer Location: *Pharmaceutical company,
Slovakia*
Application Date: *2016*

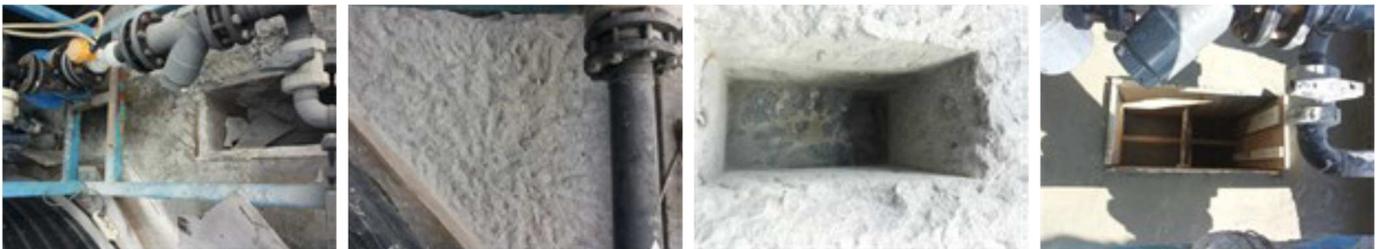
Photograph Descriptions

The acid attack had severely damaged the concrete over time, this leads to the acid not being safely stored.

1. Damaged concrete basement
2. Surface preparation
3. It was necessary to prepare firm surface
4. After Belzona application

Concrete bund on a chemical site for catching 98 % Sulphuric Acid spills.

Application was carried out in accordance with Instructions for use.

Originally was the concrete basement was unprotected. After this Belzona reconstruction was customer very satisfied with resistance of this material.
