Belzona Repair the Welding Aluminum Seams

ID: 7601

Customer Location: *Heating plant, Slovakia*
Application Date: *2014*

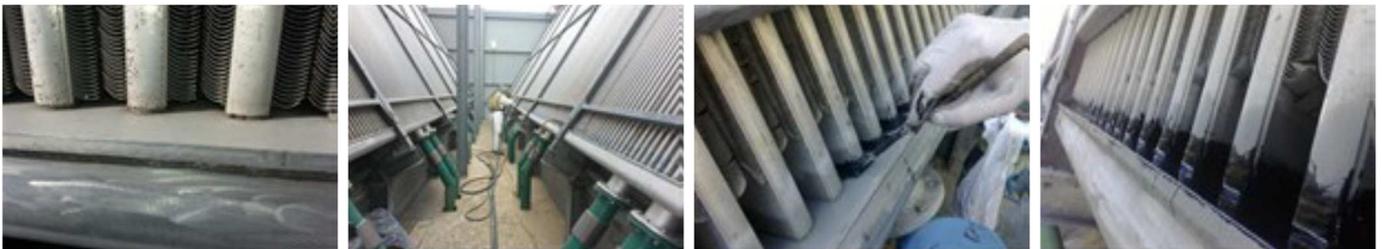
Photograph Descriptions

Cracks in the aluminium

1. Damaged vacuum condenser
2. Blasting
3. Belzona® 2211 application
4. After Belzona® 2131 application

Vacuum condenser has aluminium construction. Source of the cracks on the welding seams is mechanical movement from temperature differences.

Application was carried out in accordance with Instructions for use.

Cracks mean vacuum lost and decreasing efficiency of all devices. Local welding did not work, also cracked. After some test period with Belzona products customer made decision to apply Belzona product on all devices.
