# Belzona Repairs Pin Bush Housing

Pin bush housing on mining power shovel.

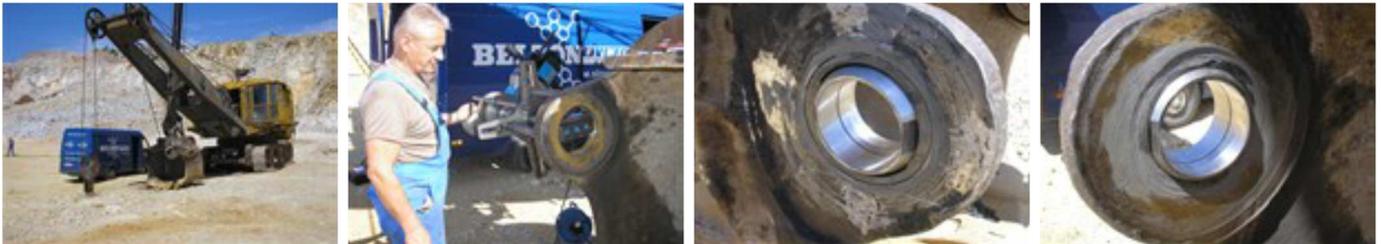
## Photograph Descriptions

*Housing had been damaged and worn down over time.*

1. Mining Power Shovel
2. Machining to proper diameter for Belzona® 1111 application
3. Bushing inserted
4. Ready for service

Conventional welding repairs would have required long lead and repair times, leaving the equipment out of action for too long. Using the Belzona method the bush could be used as a former, ensuring a perfect fit, as well as repairing the shovel with minimal downtime.
