Belzona Pump Seating Repair

ID: 7600

Industry: *Steel & Metal Processing*
Application: *CEP-Centrifugal Pumps*
Substrate: *Iron casting*
Products: *Belzona® 1111 (Super Metal)*

Customer Location: *Metallurgic plant, Slovakia*
Application Date: *2014*

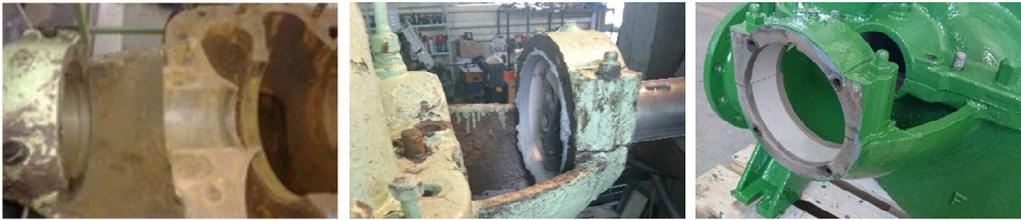
Corrosion, mechanical damage

1. Damaged pump seating
2. Machining of the Belzona® 1111
3. Ready for customer

After long time operation the pump has worn down seating. Result is a big clearance of the bearing.

Application was carried out in accordance with Instructions for use.

Welding of the seating is very difficult, takes a long time. Belzona solution means very good repair and result is that customer uses this Belzona repair also for another pumps.
