Pipe Adapter Repaired by Belzona

ID: 7825

Industry: *Transport*
Application: *SHM-Solids Handling Machinery*
Substrate: *Steel*
Products: *Belzona® 1311 (Ceramic R-Metal),
Belzona® 1812 (Ceramic Carbide FP),
Belzona® 9811 (Alumina Tiles)*

Customer Location: *Maize starch producer,
Slovakia*
Application Date: *2016*

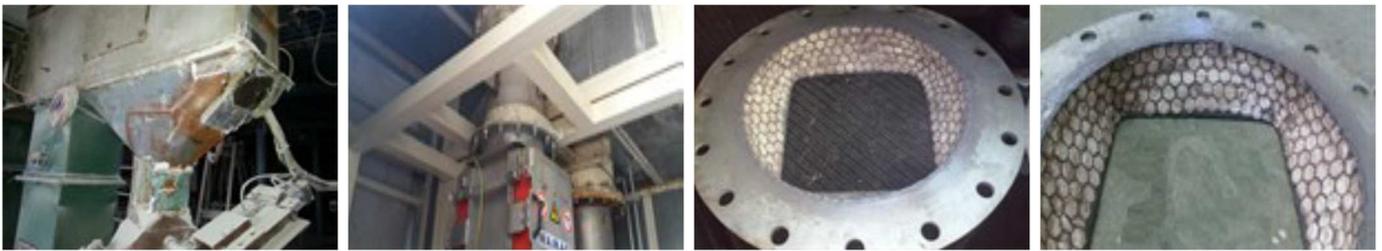
Photograph Descriptions

Maize kernels transport is very abrasive. This product is able to damage some parts of the pipe system in 6 months.

1. Pipe system for maize kernels transportation
2. Pipe adaptor in system
3. Perfect protection against abrasive maize kernels
4. Detail of the finished repair

Customer used to change some parts of pipe system before Belzona protection, but it was expensive and after 6 months was in the same situation. Then they tried to weld some steel protection against abrasion, but result was the same. Belzona solution solved these customer problems and they are satisfied with it.
